Failure of Tapo Canyon Tailings Dam

Harder, Leslie F Jr; Stewart, Jonathan P

Harder, L.F. and Stewart, J.P. (1996). "Failure of Tapo Canyon Tailings Dam," J. of Performance of Constructed Facilities, ASCE, 10(3), 109-114.

FAILURE OF TAPO CANYON TAILINGS DAM

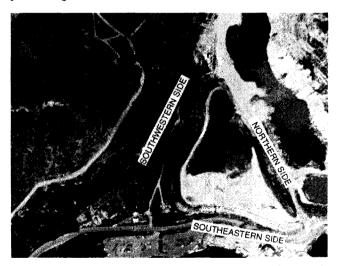
FIG. 2. Aerial Photograph of Pond No. 6 in Tapo Canyon before Northridge Earthquake (Photo by I.K. Curtis, Inc., April 1993)

but it may have been due to leakage from conveyance ditches and ponds located immediately to the north. Fig. 2 is an aerial photograph of the completed pond taken in April 1993. This photograph clearly shows ponded water in the western half of the facility.
